Commissioning Report Executive Summary

United States Diplomacy Center Owner's Project Requirements

Prepared for
General Services Administration

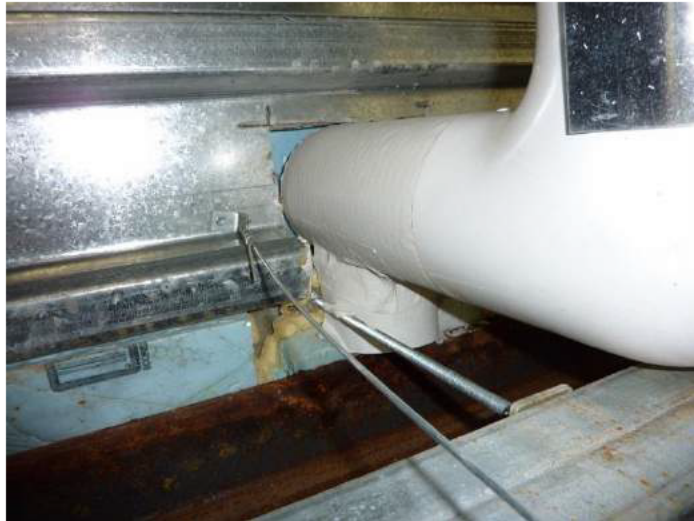
Issue #36 ctd

Roof drain as it penetrates the lower metal deck. Water was observed traveling along the metal deck ribs.

Because the lower roof is not complete, the source of the leak could not be determined at time of site visit.

Contractor to determine source of leak and repair in order to eliminate all moisture intrusion.

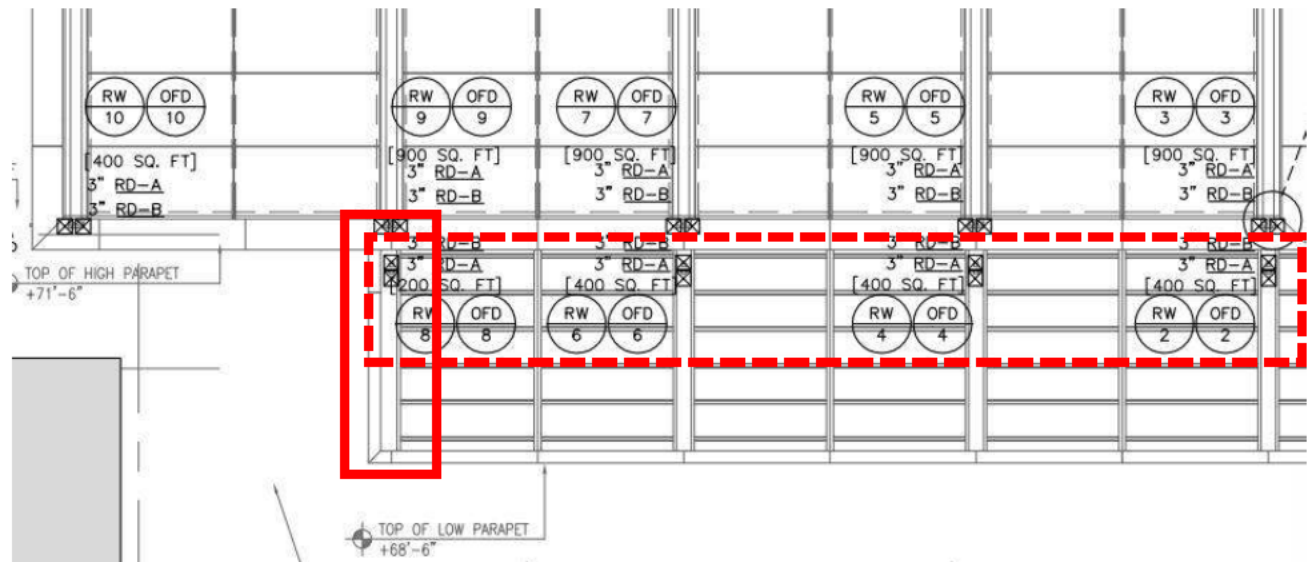
Issue #37

The western most lower roof drain on the south roof, outlined in Red below, failed allowing water to enter the building interior.

The same lower roof drains (outlined with the Red dashed line shown above) were also packed with ice and condensation potential evaluated using an infrared thermometer. Condensation concerns were confirmed with measuring surface temperature of the roof deck adjacent the lower roof drain bodies and pipe support assembly. During test, surface temperatures recorded were near dew point temperature.

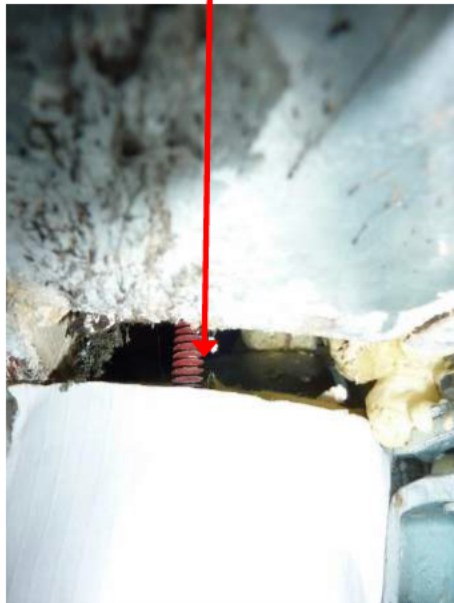
Issue #38 ctd

Photographs show gaps that must be closed and areas in which additional insulation must be applied to seal against metal deck and adjacent enclose pipe hanger.

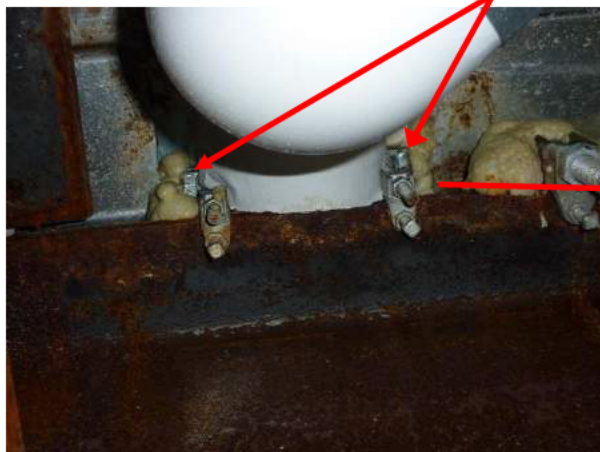
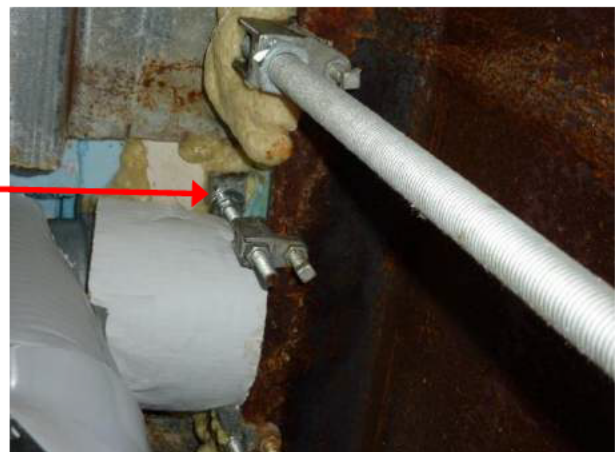
The clevis hanger body protruding beyond the insulation must be completely insulated.

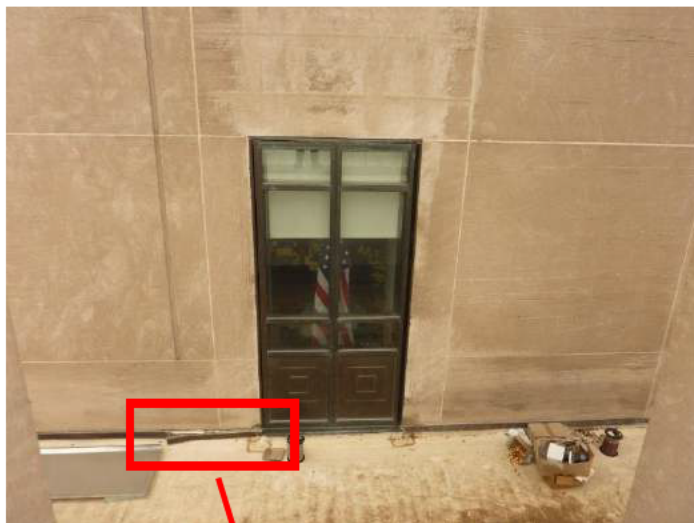
Issue #40

Image shows damaged copper flashing on the Harry S. Truman building.

Repair copper flashing.

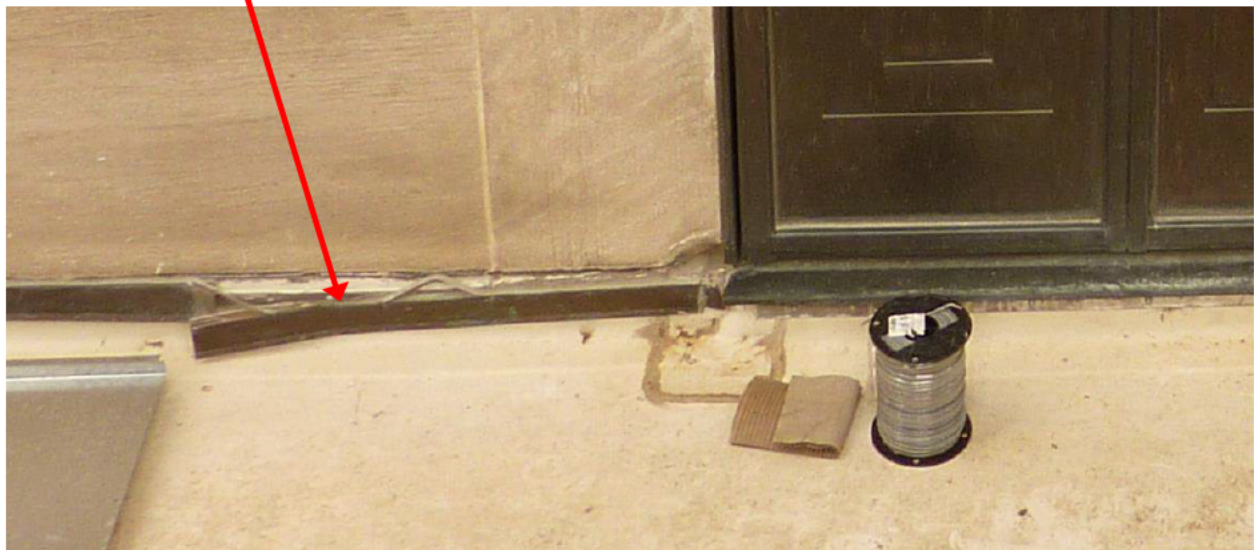
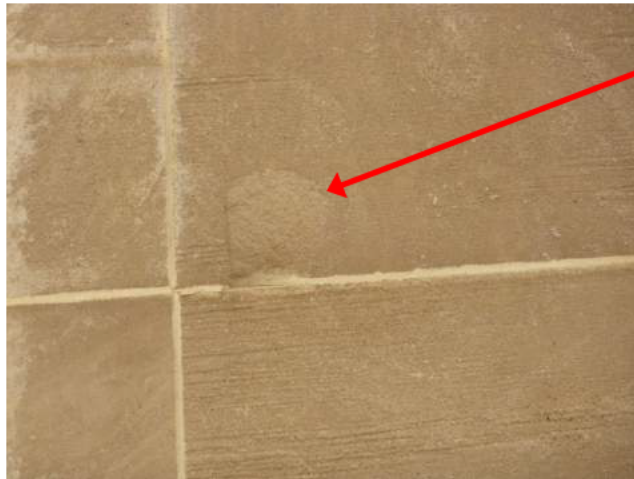
Existing Conditions

Images show spalled areas south elevation of the Harry S. Truman building adjacent USDC addition.

While contractors are currently on site, we recommend that these areas be repaired.

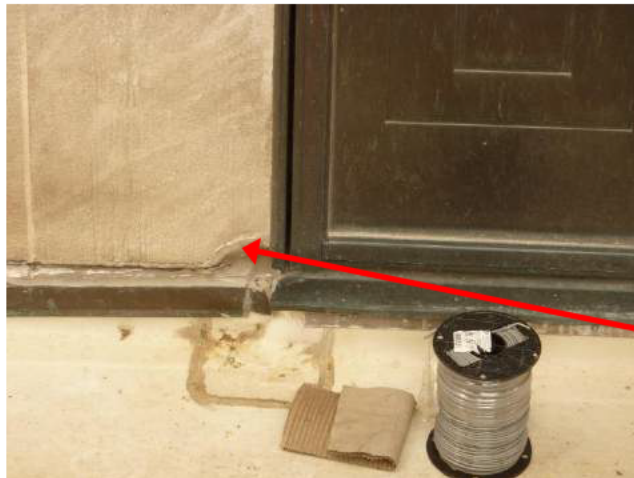
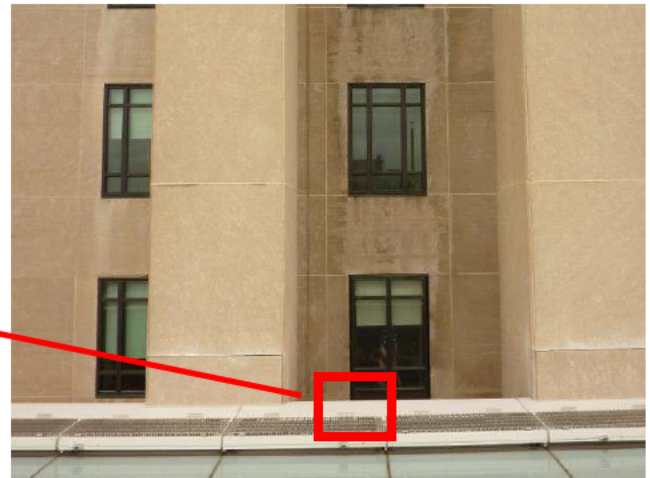
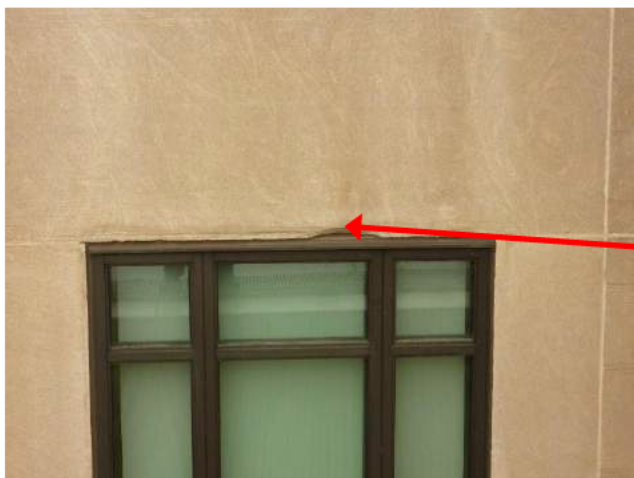
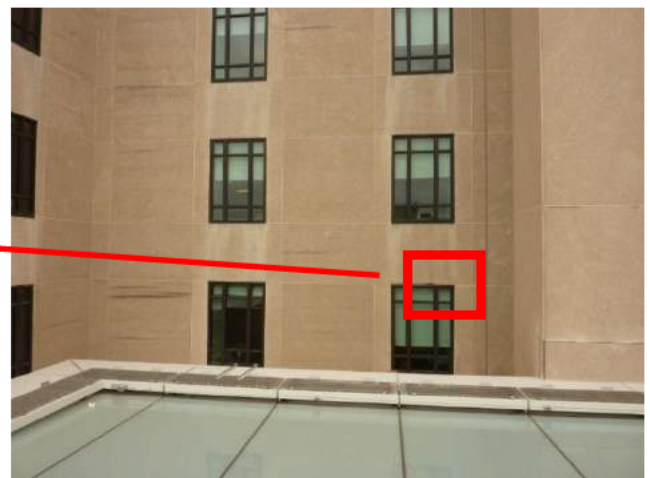
Issue #41

Typical at all four columns outlined in **red dashed line** in the elevation drawing shown below.

Cracks in the mortar joint shown at columns above the intersection with the USDC addition. These cracks are due to movement of the lower lime stone panel probably due to removal of lower stone section to accommodate tie in to new construction.

Remove and replace cracked mortar joints.

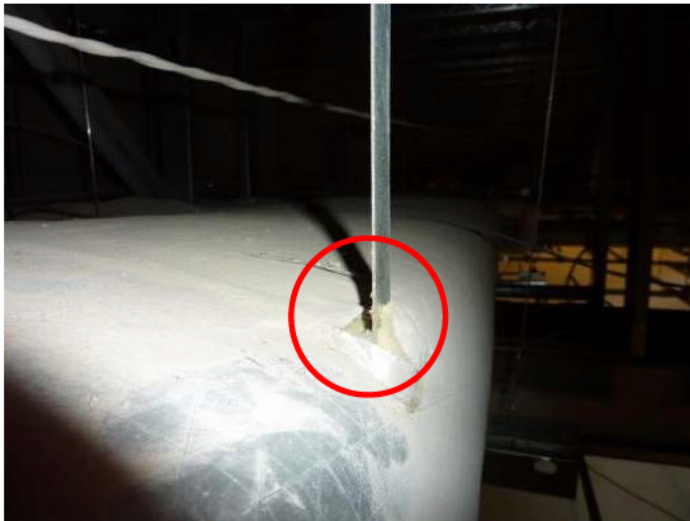
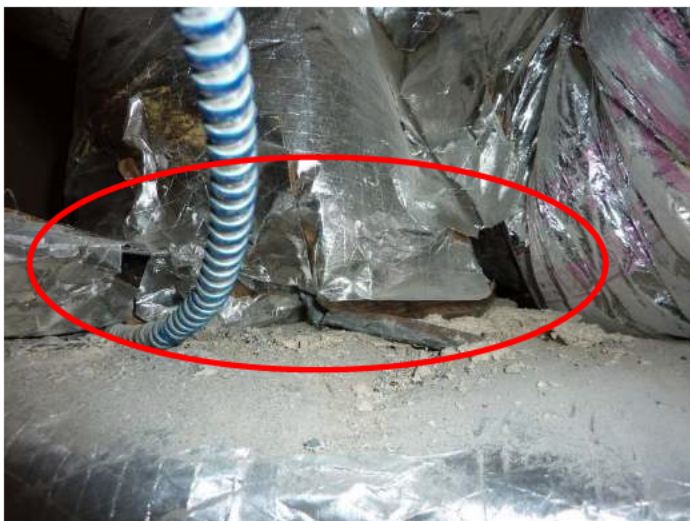
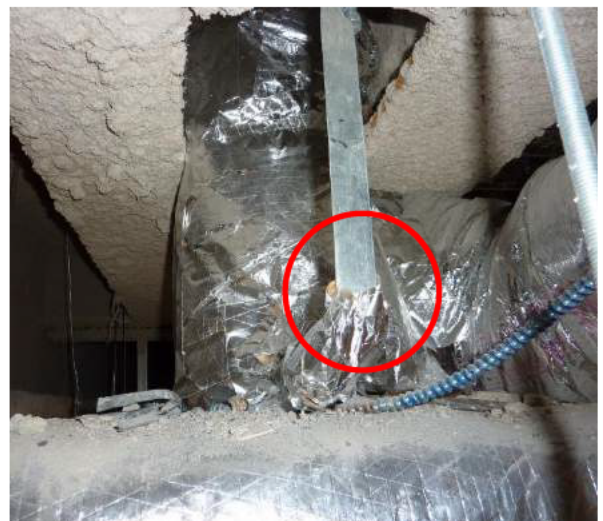
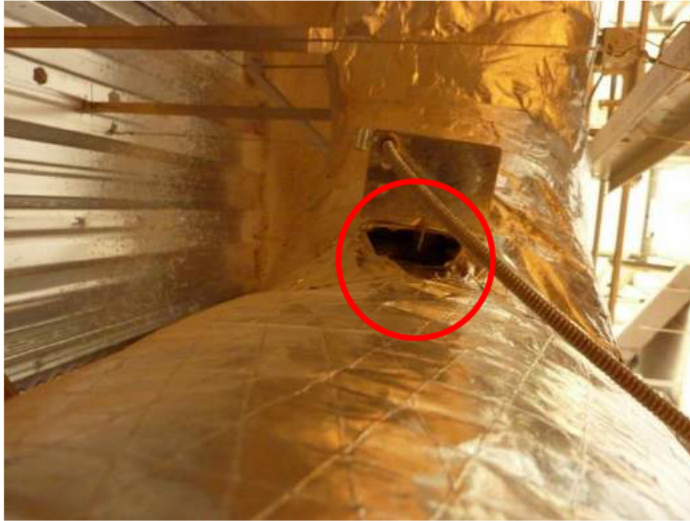
Issue #42

Vapor barrier discontinuities have been identified in a number of areas.

Seal vapor barrier at all penetrations, intersections, and terminations at assemblies.

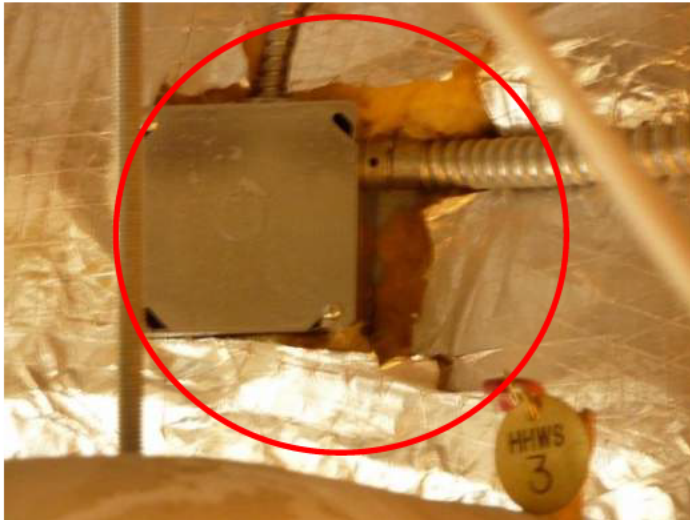
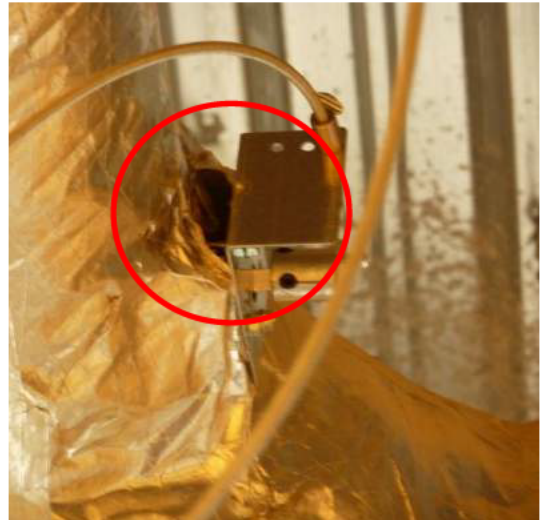
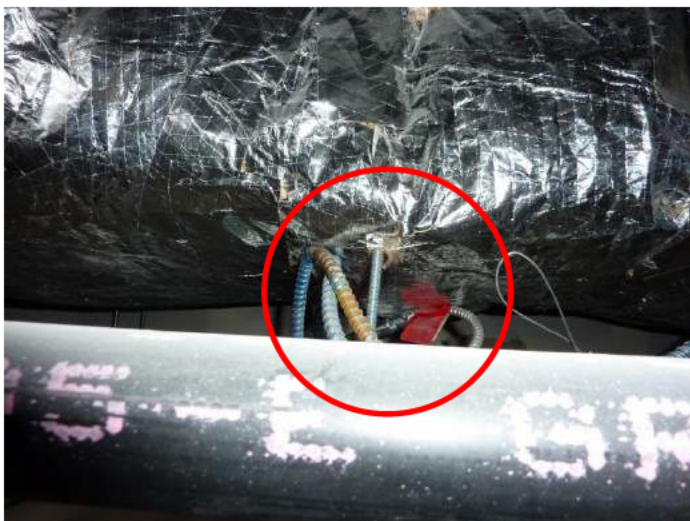
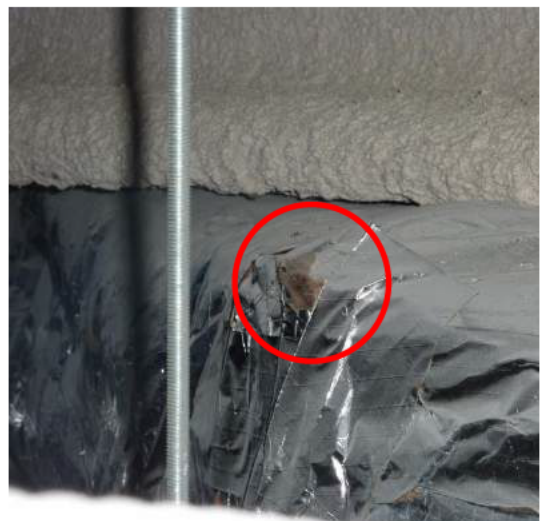
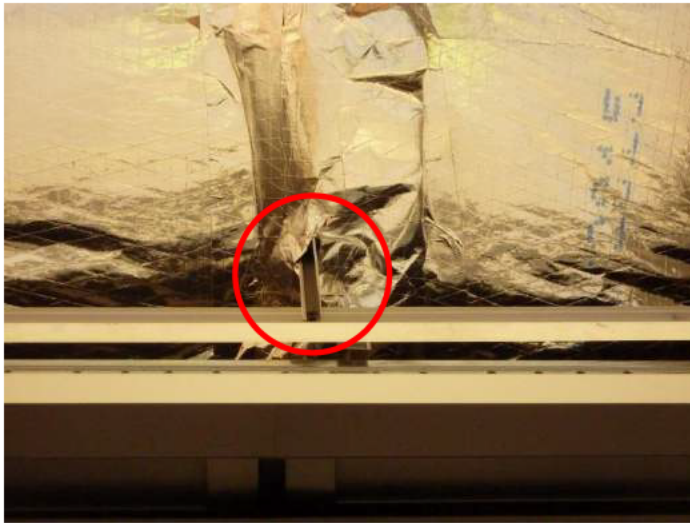
Issue #42 ctd

Vapor barrier discontinuities have been identified in a number of areas.

Seal vapor barrier at all penetrations, intersections, and terminations at assemblies.

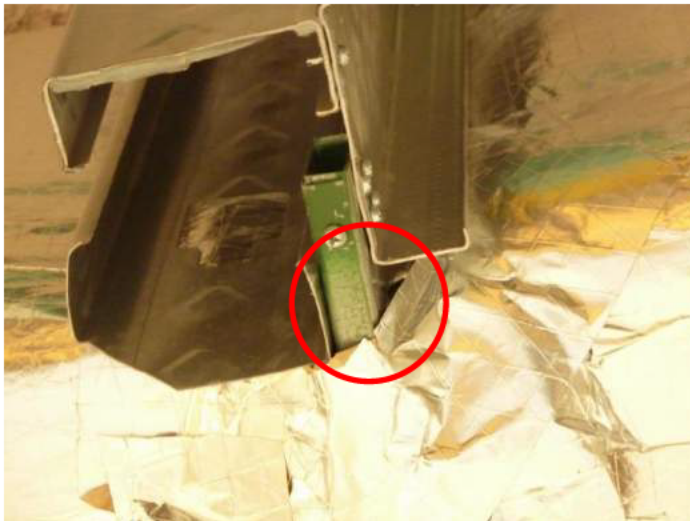
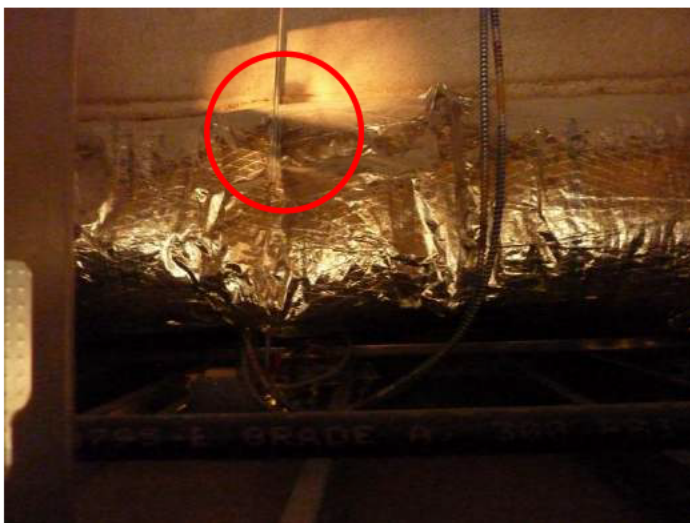
Issue #42 ctd

Vapor barrier discontinuities have been identified in a number of areas.

Seal vapor barrier at all penetrations, intersections, and terminations at assemblies.

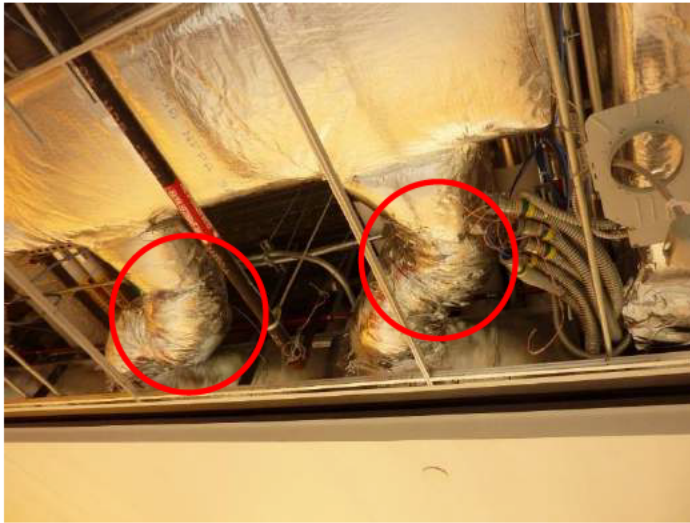
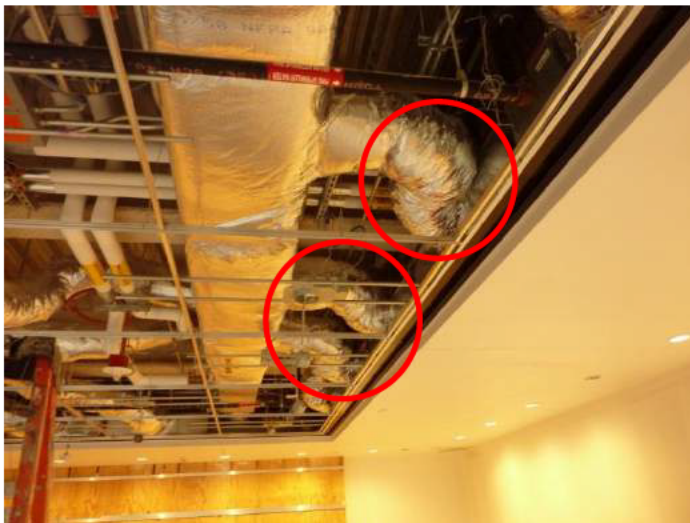
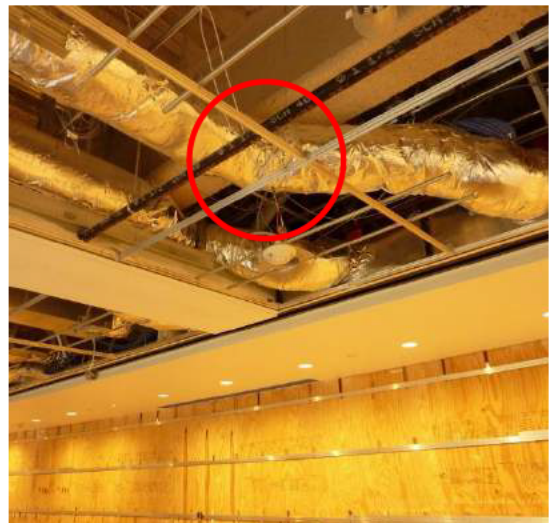
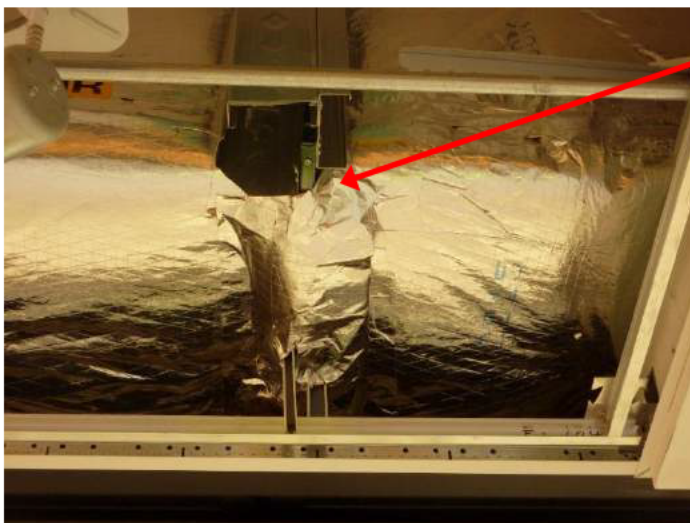
Issue #44

A number of duct sections have not been installed fully extended and have an un-necessarily tight bend radius. This condition causes a need for increased fan power in order to supply airflow, increasing energy consumption by the HVAC system. Install flex duct in accordance with ADC Flexible Duct Performance & Installation Standards and ASHRAE Handbook of Fundamentals 2013 to minimize pressure drop and flow restrictions.

Duct section is compressed by adjacent assembly. Reducing insulation effectiveness.

Reinstall duct in a position to eliminate compression and reduced insulation thickness.

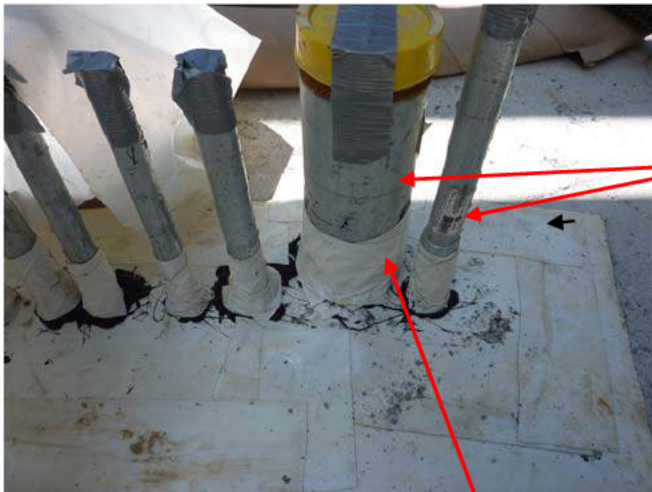
Issue # 1

Typical basement waterproofing of electrical conduit missing ADCOR ES waterstop.

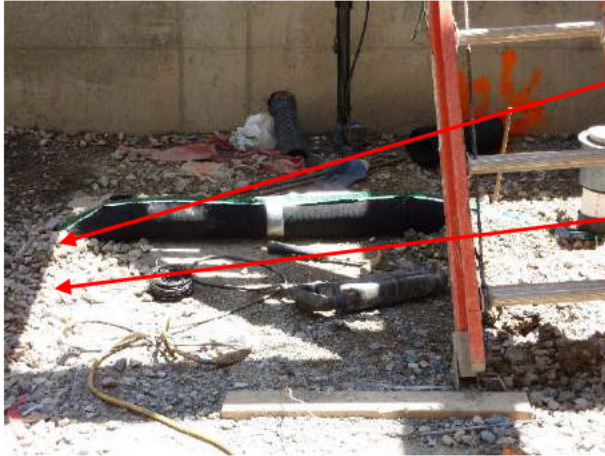
Issue # 2

Under mud slab drainage piping is more than 50% below top of grade beam.

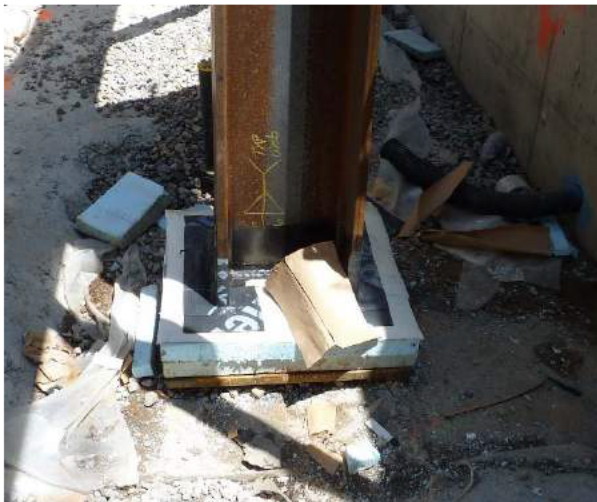
Issue # 3

Gravel drainage bed appears to be a mixture of gravel and soil which does not meet spec section 31 000 drainage course requirements for a clean drainage course.

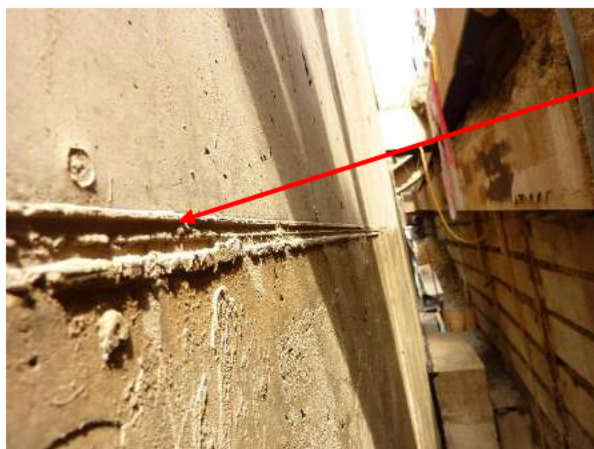
Issue # 5

Southeast corner requiring patching to provide a smooth surface prior to application of Bituthane membrane. Patch mortar, or grout and trowel smooth in accordance with manufacturer's installation instructions.

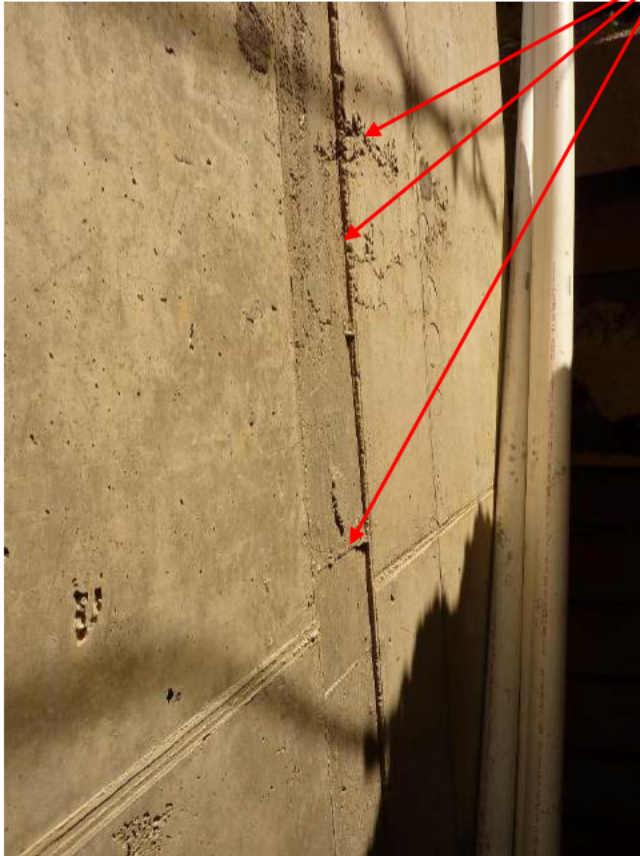
Issue # 7

East wall at southeast corner requiring patching to provide a smooth surface prior to application of Bituthane membrane. Patch mortar, or grout and trowel smooth in accordance with manufacturer's installation instructions.

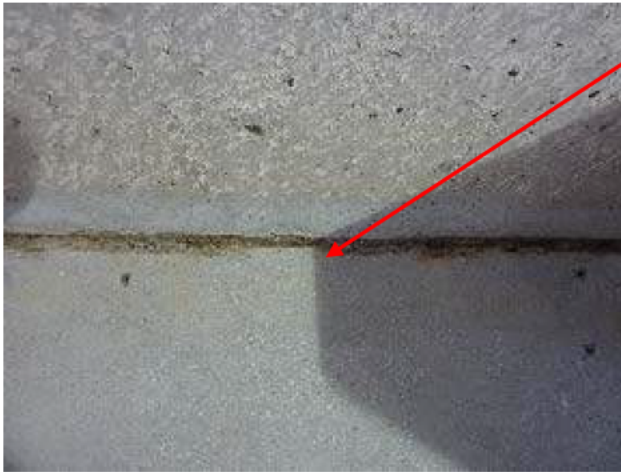
Issue #9

Sealant primer being applied along grid line PC of mechanical room B101 not extending width of sealant being applied. Recommend installing contractor apply primer slightly beyond full width of sealant being applied. Observed contractor correct and apply primer as recommended by manufacture. Request installation foreman increase diligence in installing waterproofing materials per manufacturer.

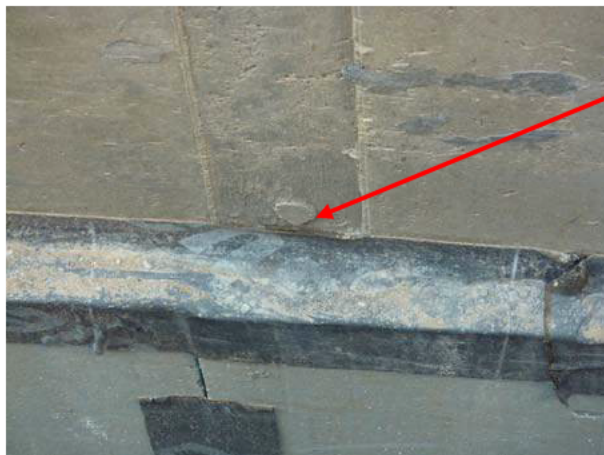
Issue #10

Previous Issue #7 not addressed during construction. Recessed area in concrete requires filling to provide smooth surface to prevent voids that hinder good adhesion as shown in temporary application of Bituthene. Recommend prior to next application of sheet waterproofing troweling smooth depressions and protrusions per manufacture installation instructions

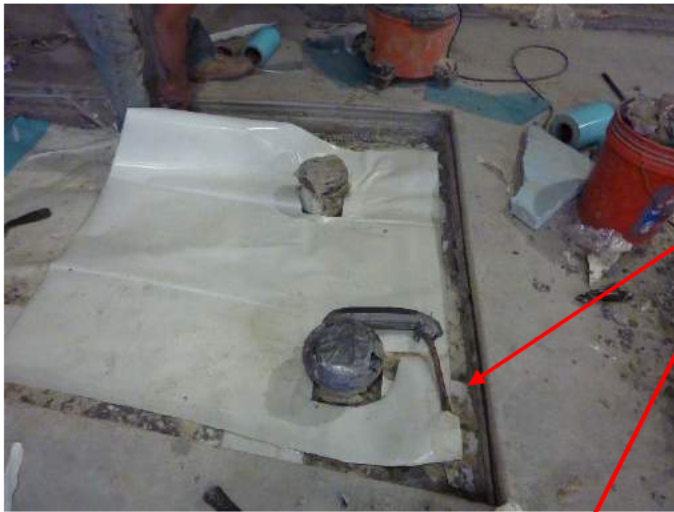
Issue # 11

Numerous areas were observed in the basement floor not ready for lapping of Preprufe waterproofing membrane. Ensure the underside of the succeeding sheet is clean, dry and free from contamination before attempting to overlap. See manufacture's installation instructions

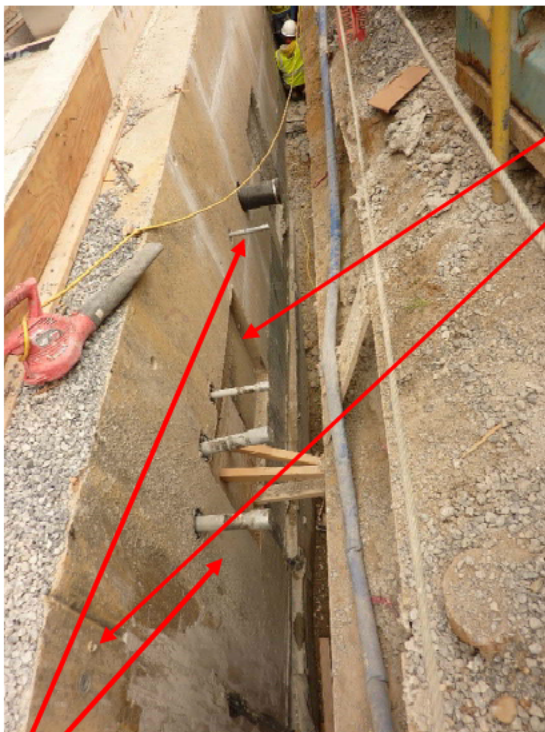
Issue # 12

Contractor is in process of filling in prepping the concrete substrate in preparation of applying sheet waterproofing. Several areas with gaps larger sheet water proofing can span still require to be filled in.

Prior to reapplication of waterproofing primer on concrete substrate the substrate must be free from spalled areas, loose aggregate, sharp protrusions or other matter that will hinder the adhesion or regularity of the membrane installation. The surface should also be free from frost, dirt, grease, oil or other contaminants as outlined in the manufactures installation instructions.

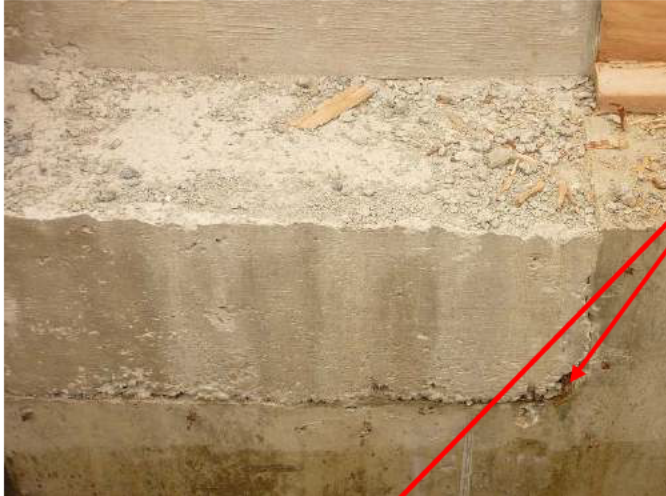
Issue #13

Typical condition to Issue #12 instructions. Patch rough wall areas with mortar, grout or approved sealant. Remove fins and form match lines.

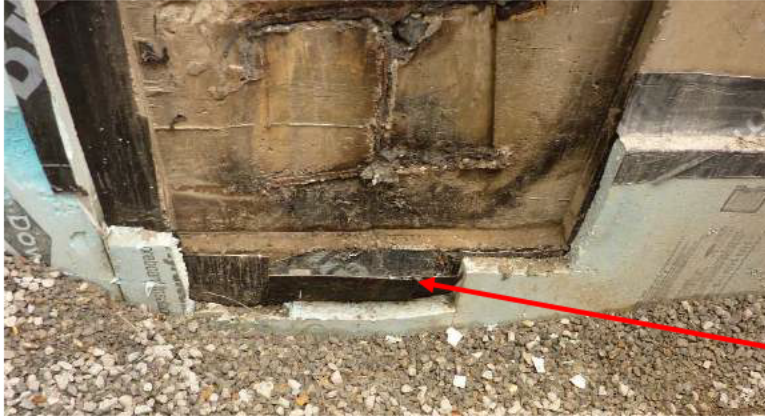
Issue #15
Damaged waterproofing
requiring repair with a
minimum 6" lap over existing
membrane.

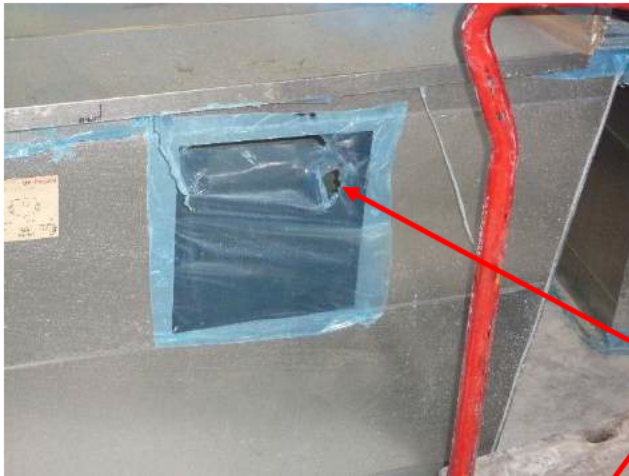
Issue #16

Duct protective seal broken requiring repair in accordance with Construction IAQ requirements. Protection of electrical equipment from dirt and debris that can affect transformer's ability to cool properly.

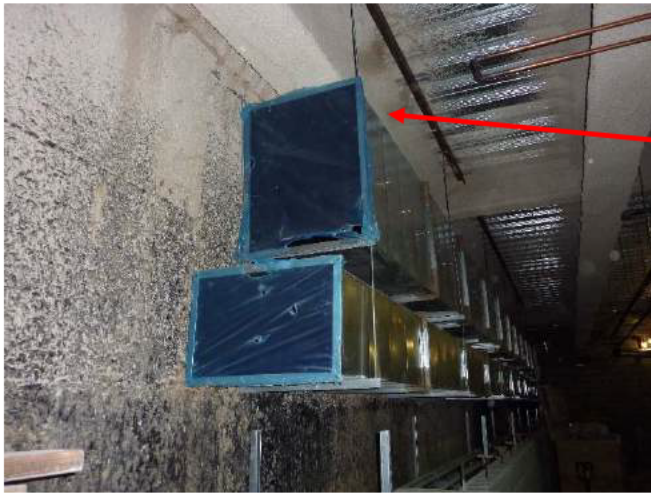
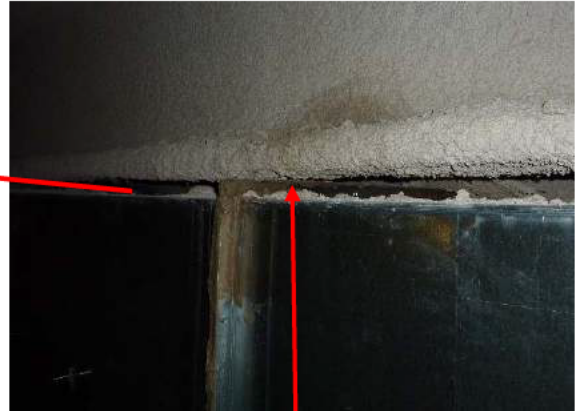
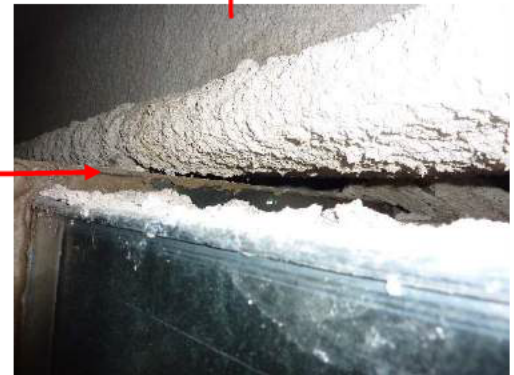
Issue # 17

Insufficient space to properly insulate ductwork and maintain insulation value and vapor barrier integrity.

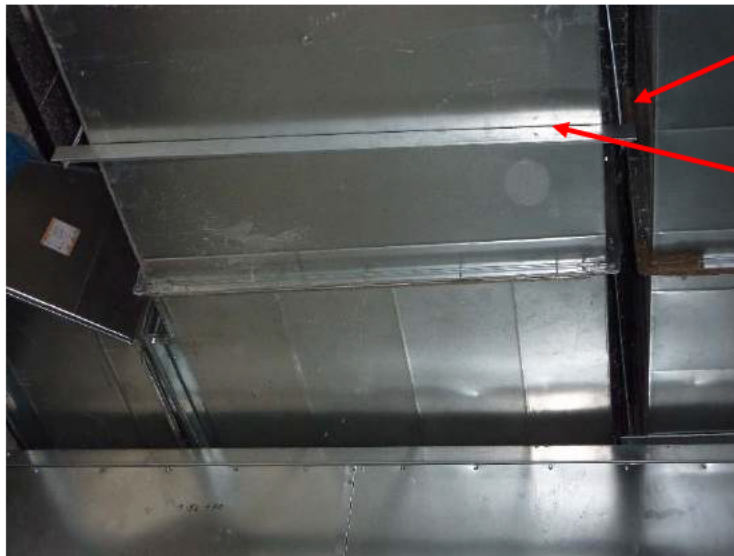
Issue #18

Insufficient space to allow insulation installation.

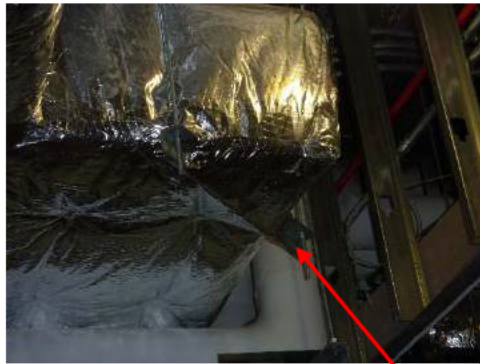
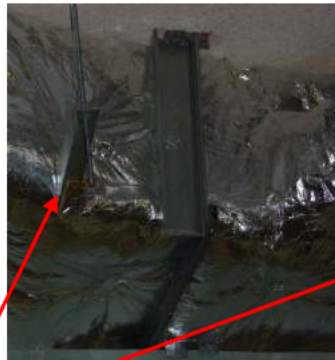
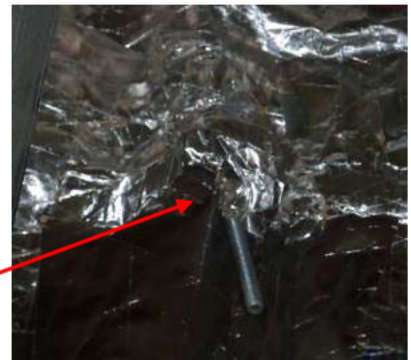
Incorrect installation of insulation of HVAC ducts were observed throughout. Duct hangers cannot be insulated around. Integrity of insulation and vapor barrier must be maintained.

Typical condition observed throughout requiring correction.

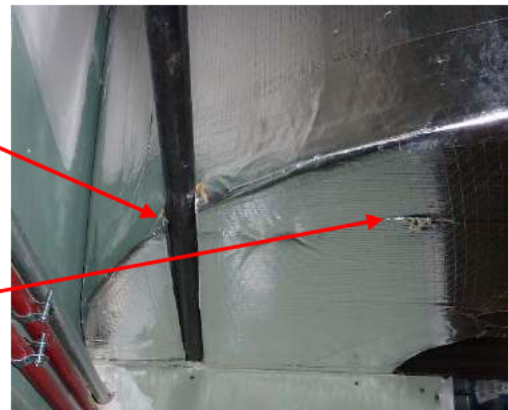
Issue #26

Breaches in vapor barrier observed throughout. All breaches must be sealed.

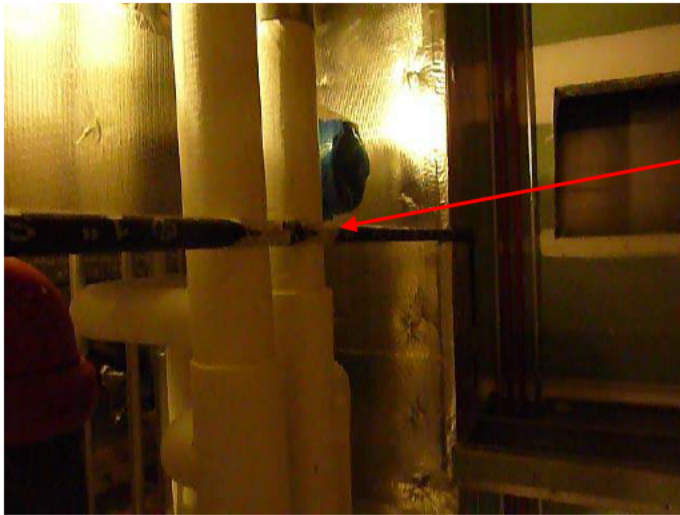
Issue #25 Continued

Pipe insulation cannot be removed to allow installation of other infrastructure. Condition observed in several isolated areas requiring correction.

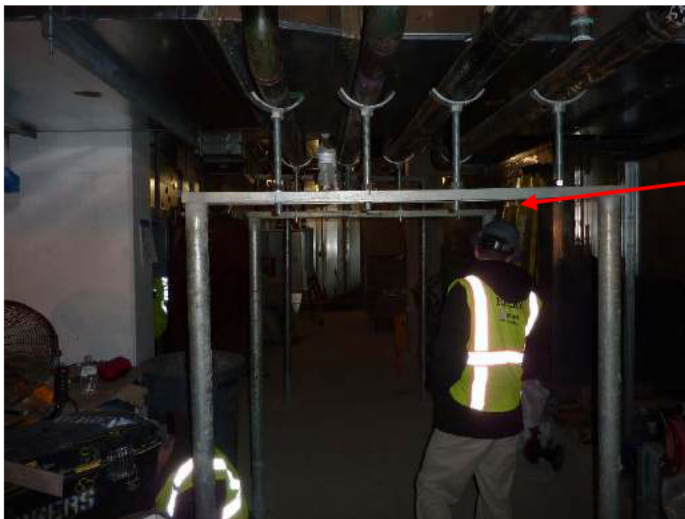
Issue #27

HVAC Pipe Bridge poses physical hazard to building operators due low height and need head clearance.

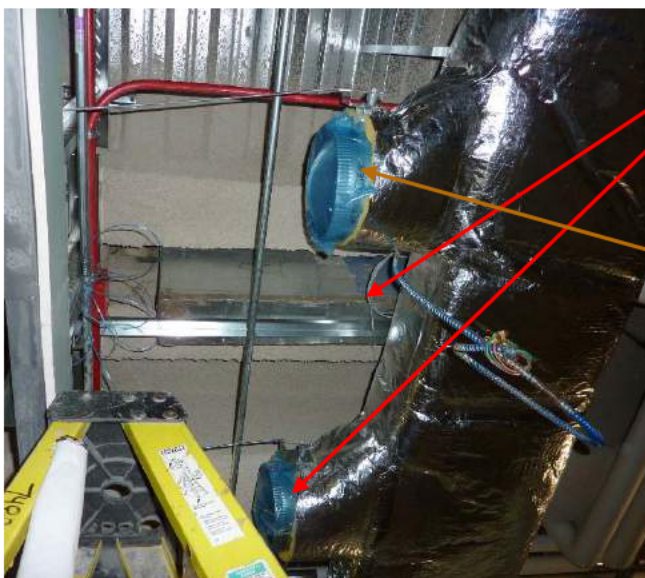
Issue #28

Insufficient clearance and spacing to allow correct installation of flex duct to floor diffusers above which will add additional static pressure to HVAC system.

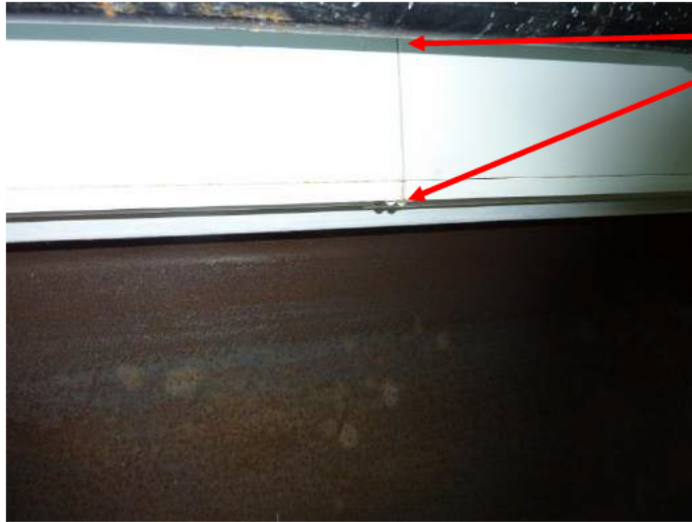
Issue #24

Locations of water observed in interior below north skylight parapet wall

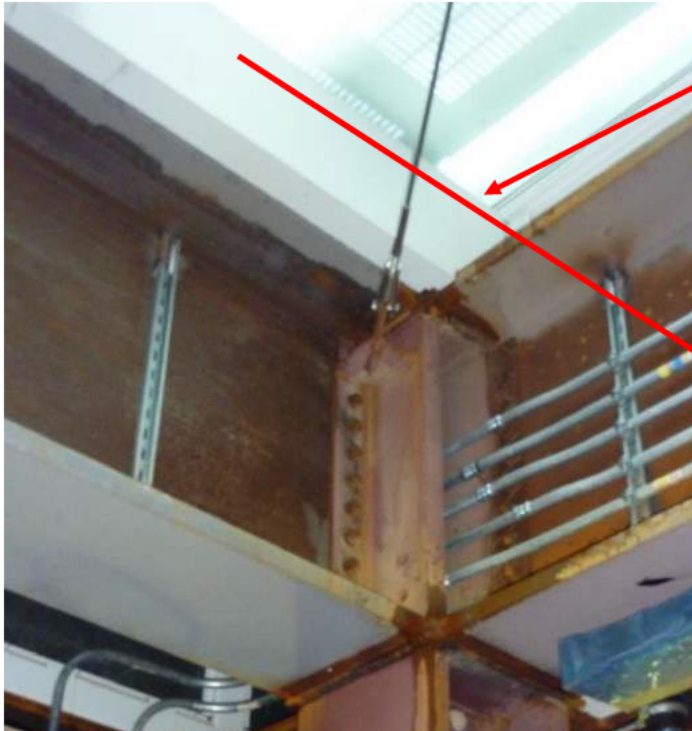
Issue #25

Location of water intrusion
observed below skylight southeast
corner.

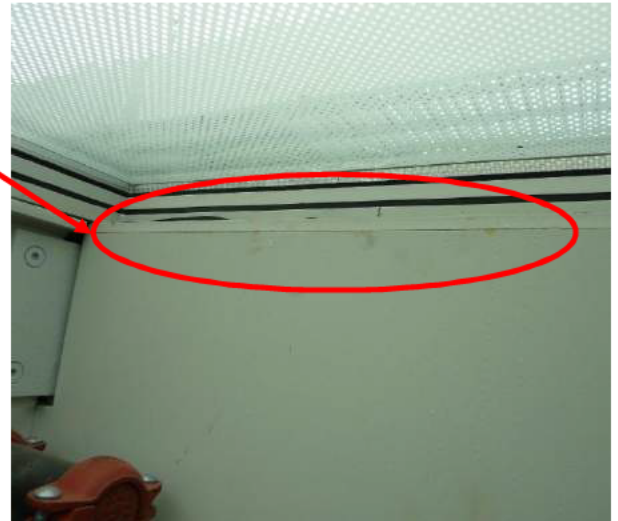
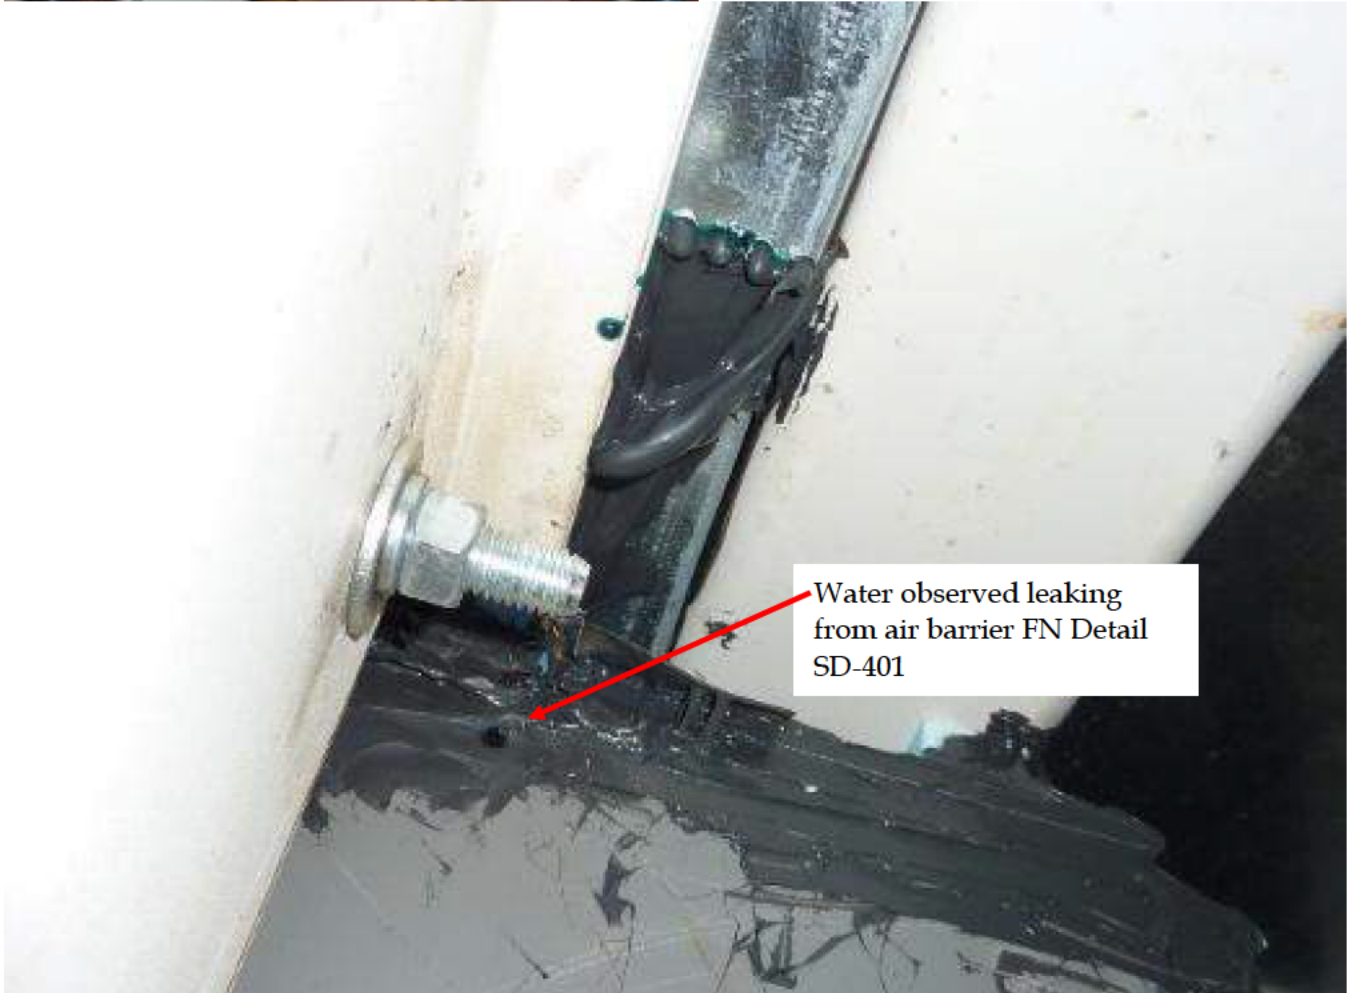
Water observed leaking
from air barrier FN Detail
SD-401

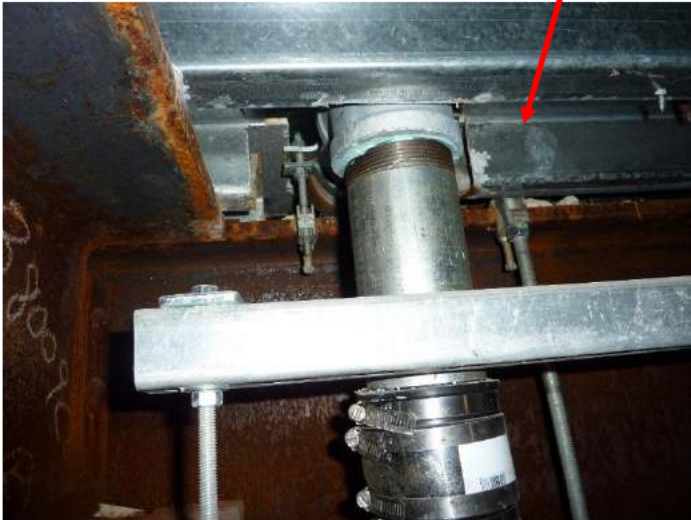
Issue #26 Lower roof drain
As designed and installed there does not appear to be a way the assembly can either insulated or isolated to adequately prevent or control condensation from forming on the assemblies exterior and water dripping from the assembly to the ceiling below.

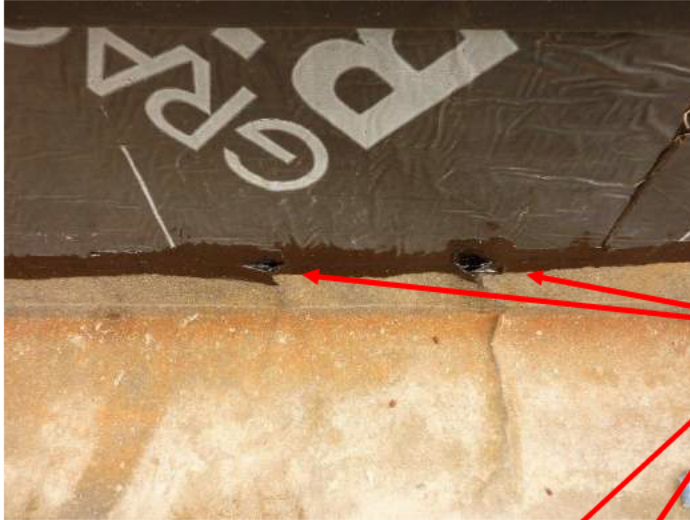
Issue #27

Multiple breaches observed in waterproofing along South Foundation requiring correction.

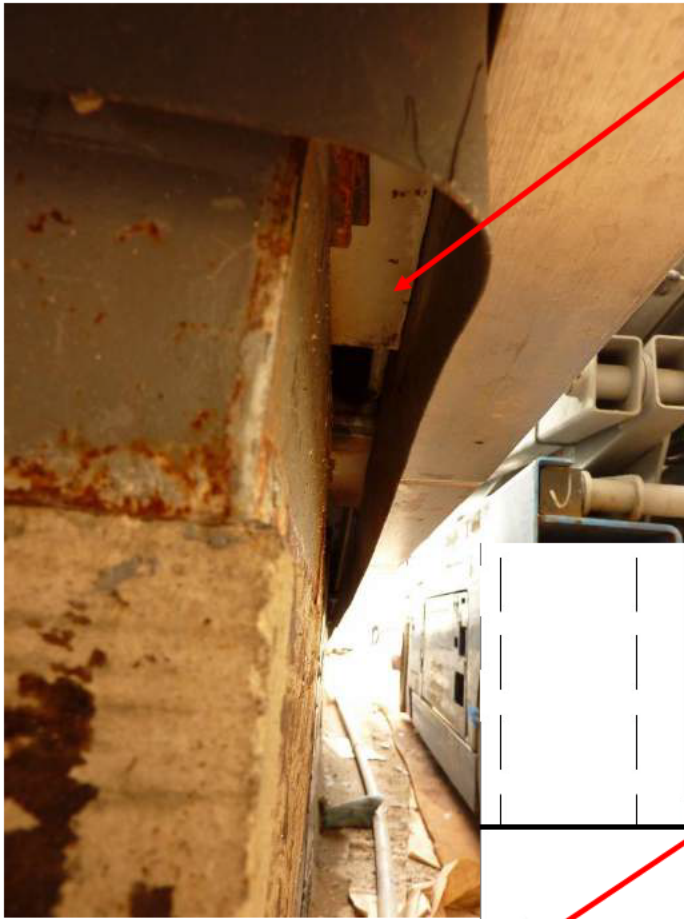
Issue #28

There is a breach in the air/water/thermal barriers between insulated Curtain Wall and the foundation of the US Diplomacy Center.

Design documents does not indicate that the foundation edge above grade will be insulated which will result in condensation during winter months to form within the interior wall assembly.

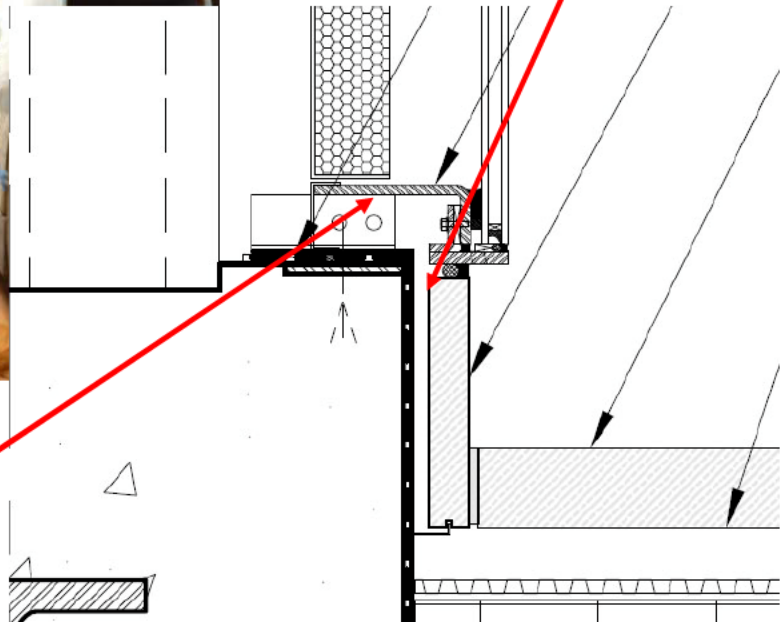
In addition stainless steel support for the curtain wall is a thermal bridge through the assembly to the building interior.

Interior view illustrating lack of thermal insulation and discontinuity of air/water barrier
